Somerville Marginal CSO (MWR205) Status and Update

Richard Trubiano, MWRA
Robert King, City of Somerville

Mystic Water Quality Science Forum
January 24, 2013

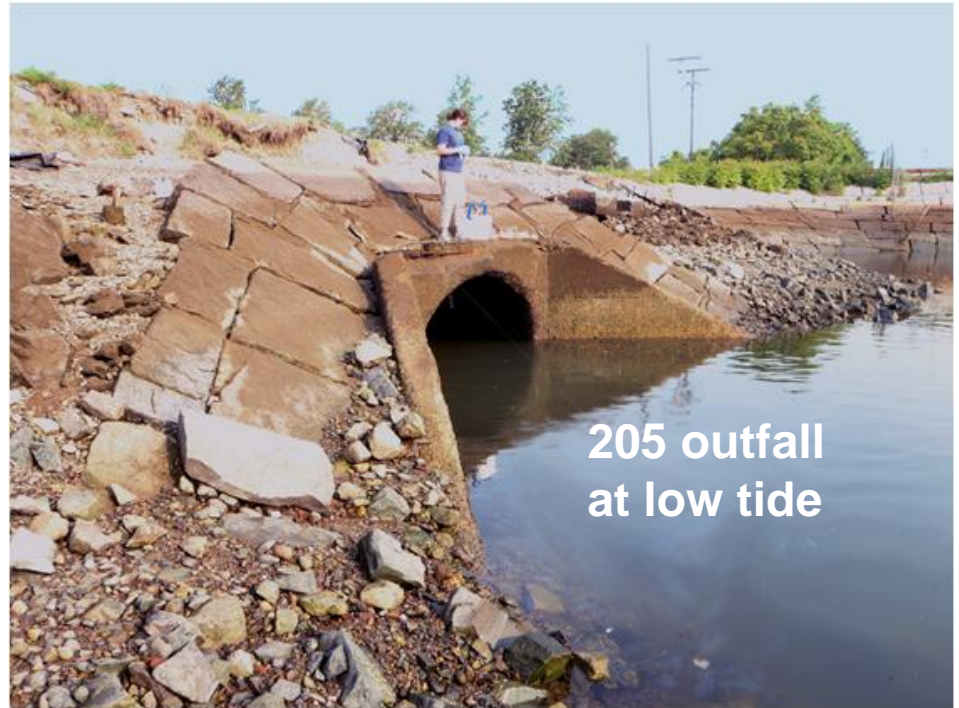
- 1) the 205 outfall discharges downstream of Amelia Earhart dam into Mystic River mouth.
- 2) If tide is high, discharge also occurs upstream of Amelia Earhart Dam near Assembly Square via outfall 205A.

**205 outfall
at low tide**

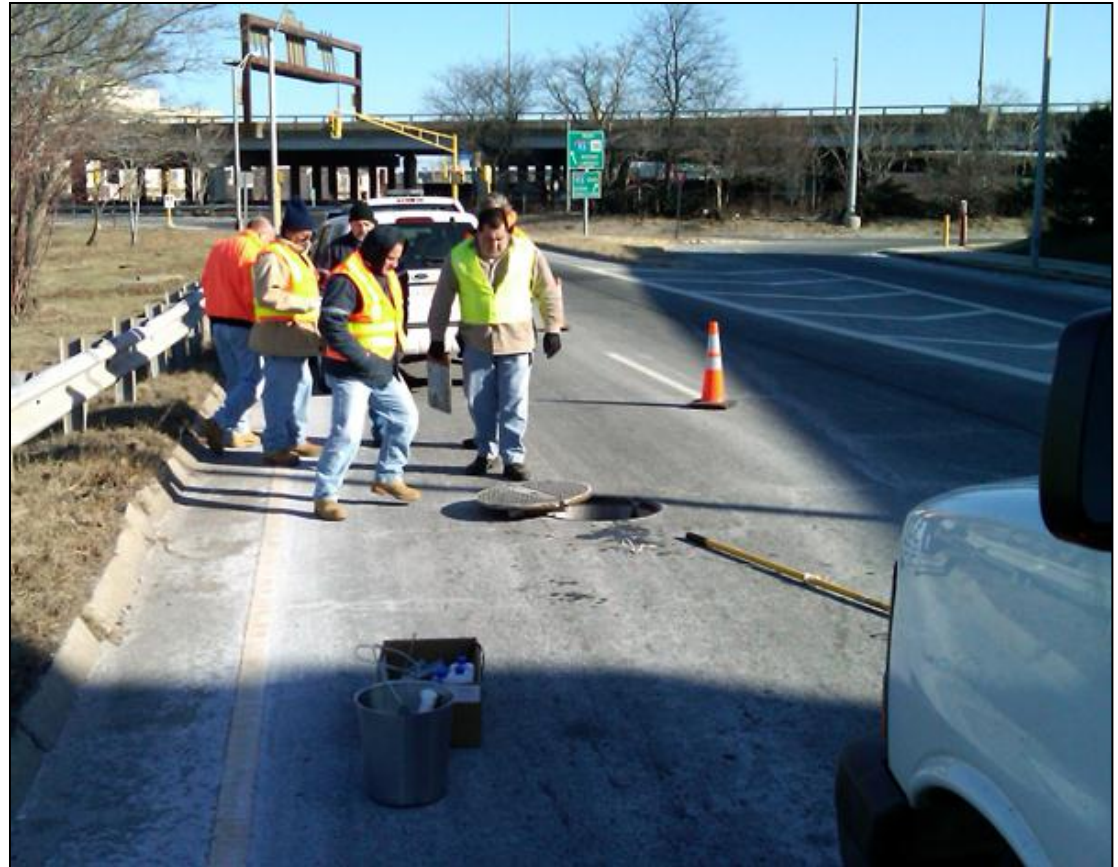
February 2010 – sampling upstream of Somerville Marginal Facility

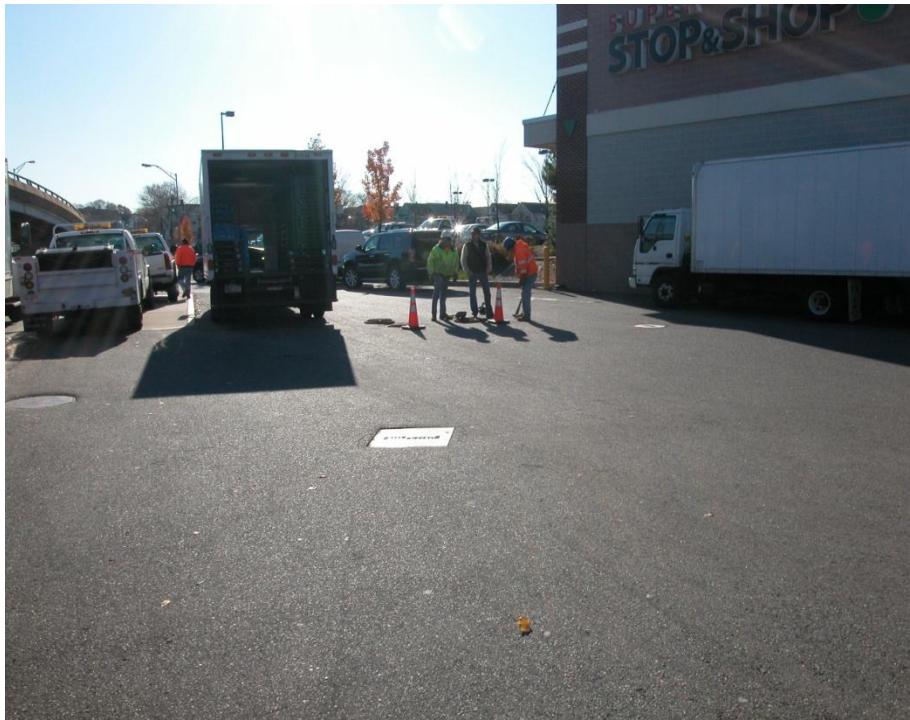
Staff inspecting Stop & Shop's fats-oils-grease separator

- Collected samples in the area of blockage
- In November 2009, blockage cleared with Vactor Jet
- TV-inspected 8" sewer and 12" storm drain
- Inspected Stop & Shop and their FOG Separator
- Stop & Shop hired a contractor to cleaned out their FOG Separator

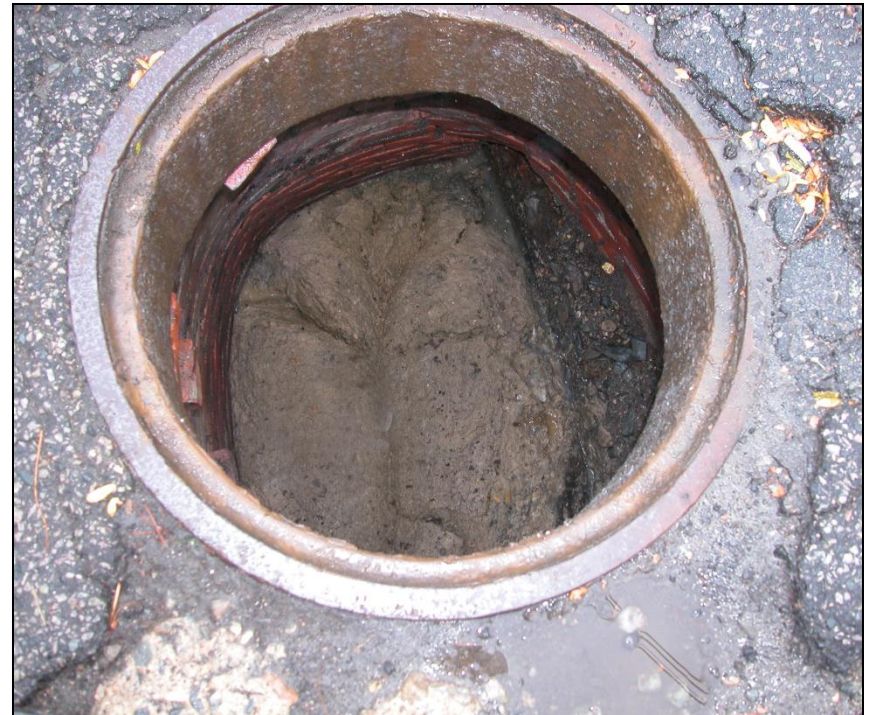
Example of sewer line blocked with grease

MWRA and Somerville staff identify an 8" sewer line blocked with grease which caused a back-up into a City of Somerville 12" storm drain that flows to the 205 conduit.

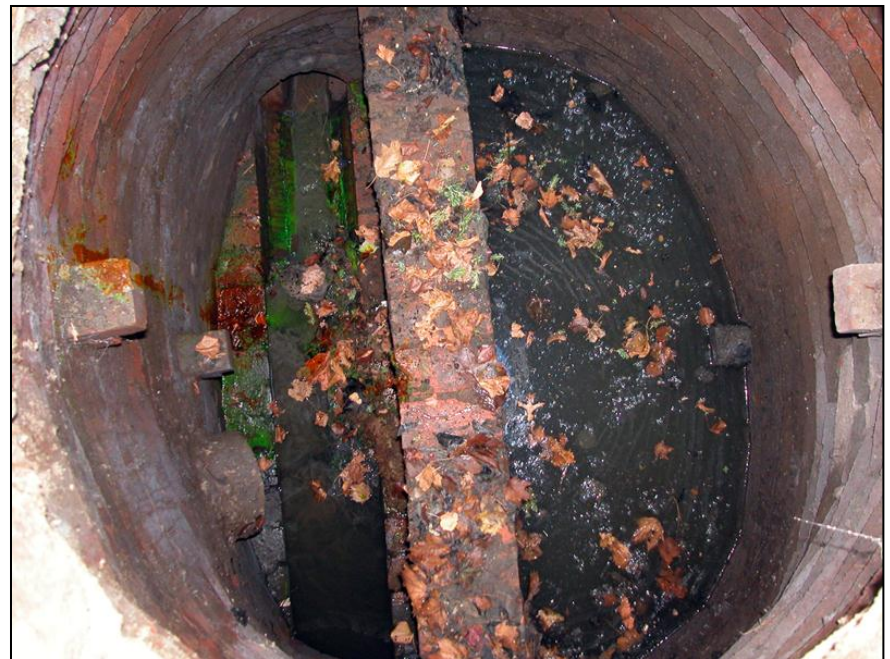
Dye testing in combined sewer (dye is sewer side), after cleaning. In event of a grease clog, sanitary flow would overtop the weir into a storm drain line to the Somerville Marginal conduit.

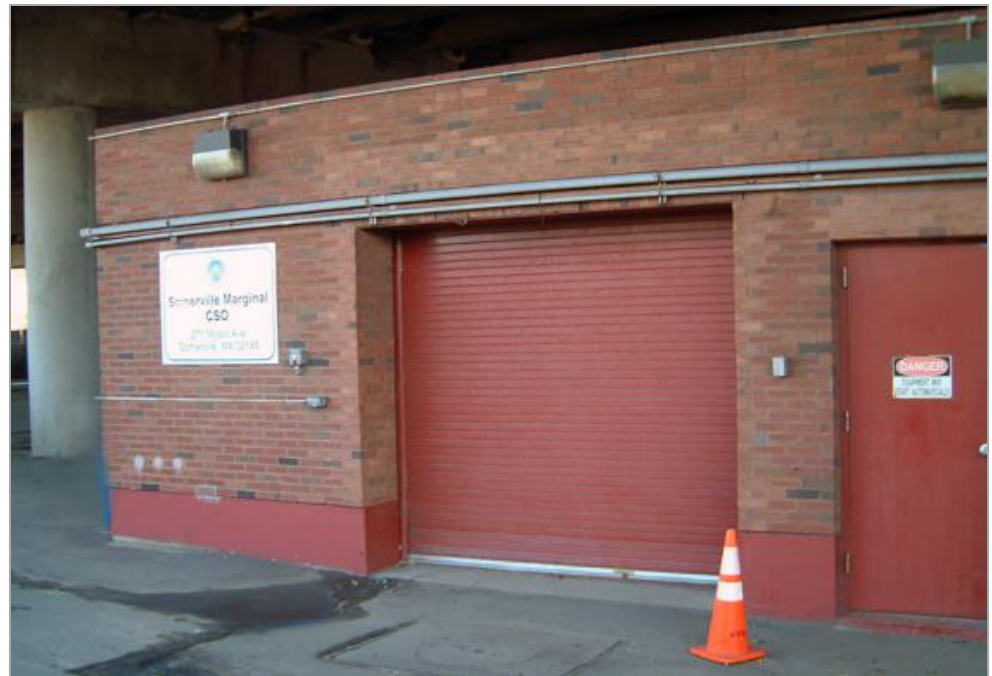
To address any potential leakage through influent gates:

- Float activated sump pumps were installed between the influent stop logs and the Influent gates
- Temporary bulkhead installed upstream of influent gates
- Initiated planning/design for new influent gates

- Influent gate and stop log replacement included installation of two main influent sluice gates, four sets of stop logs, and installation of two channel dewatering pumps to maintain air gap between influent channel and the Somerville Marginal conduit in dry weather.
- Started in August 2011 and finished November 2011.
- Project cost - \$364,000

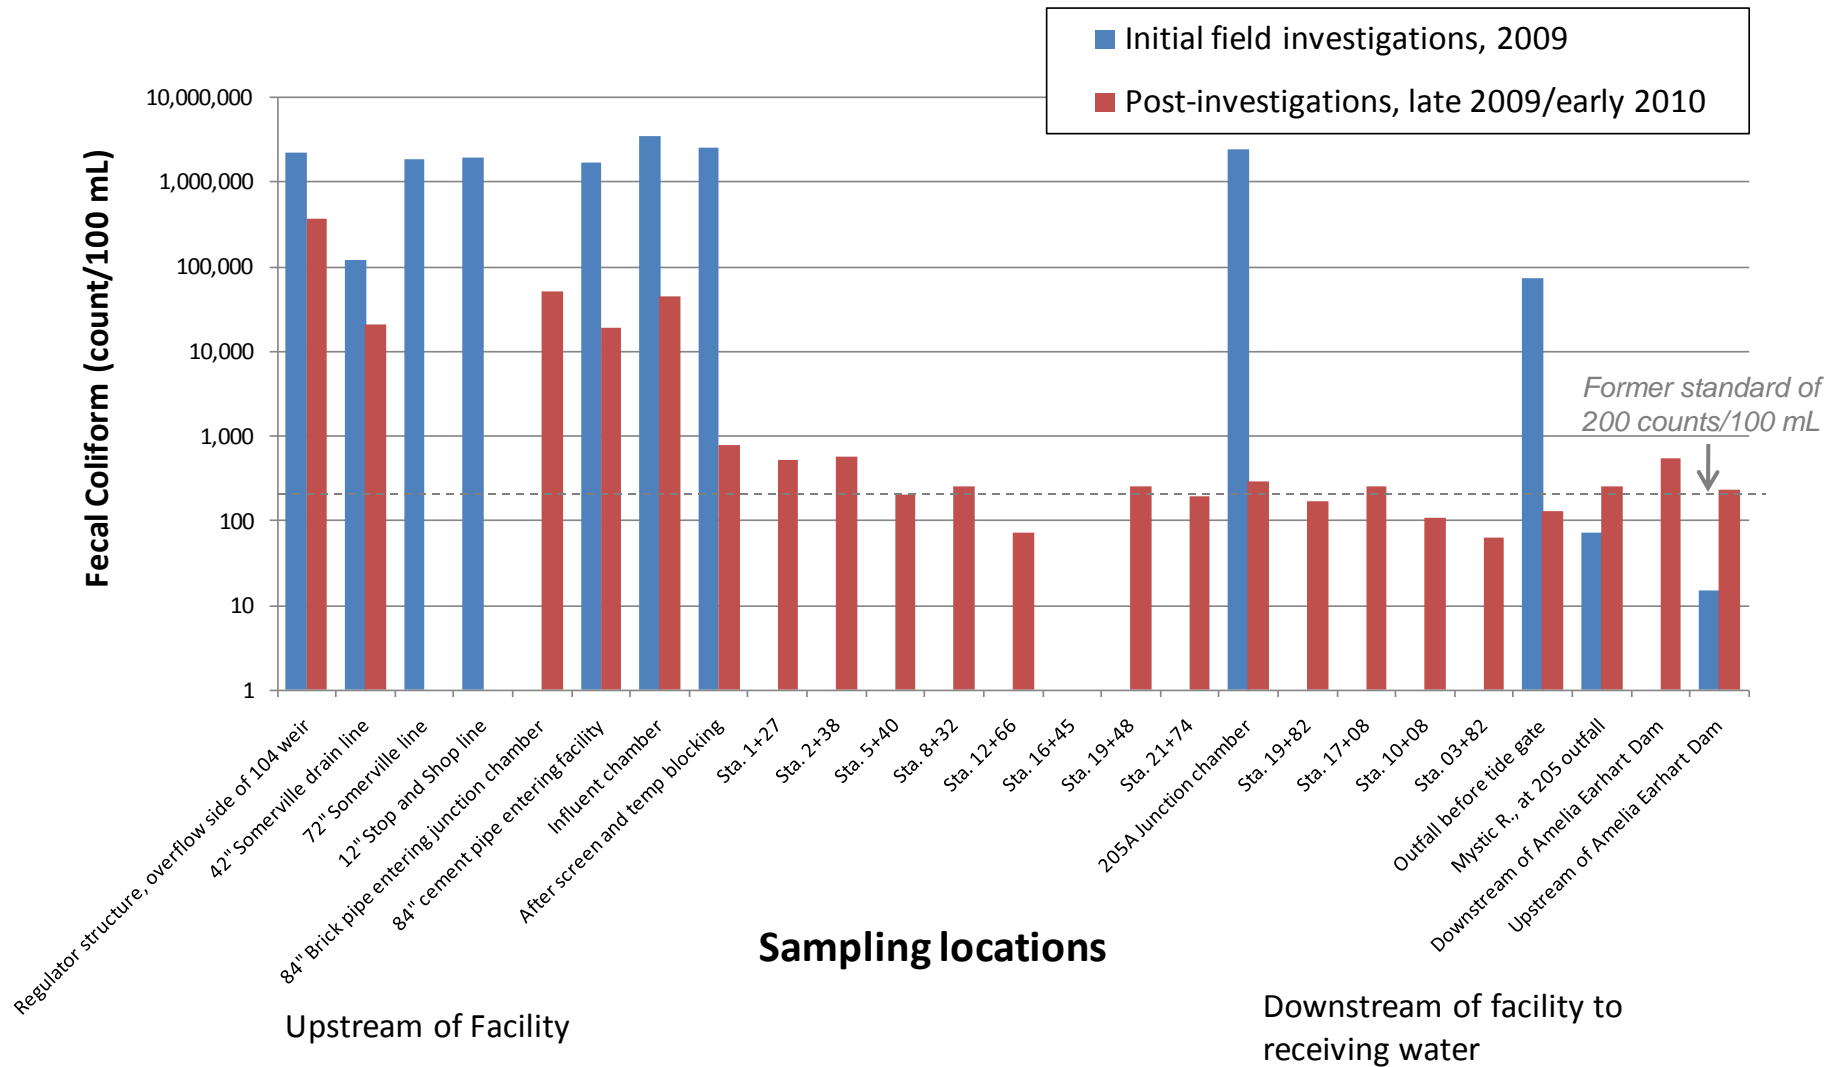
205 conduit bacteria results before and after investigations 2009-10

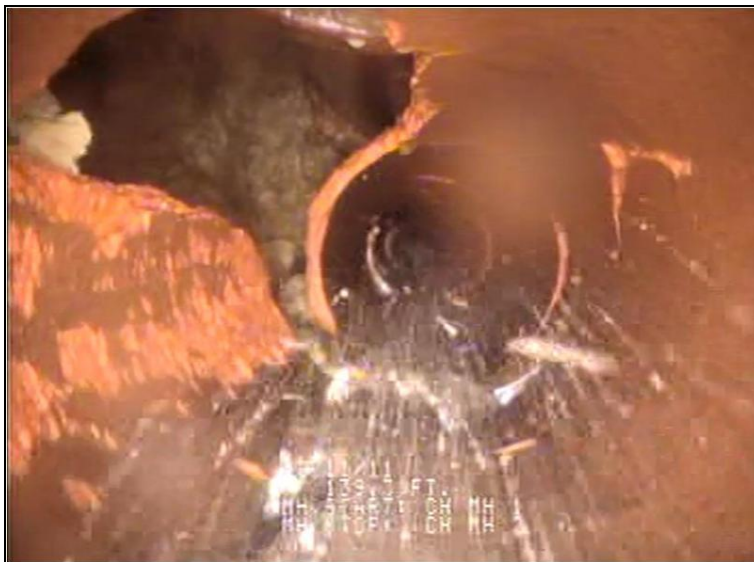
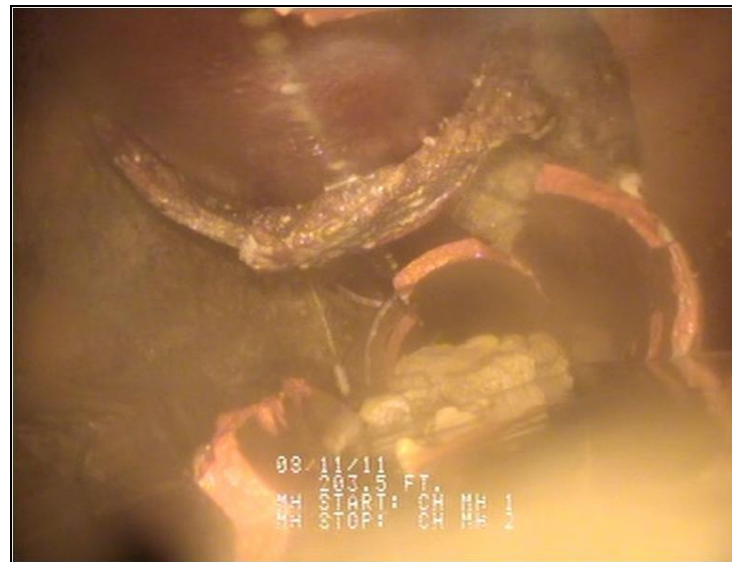
TV inspection images, August 2011

*CCTV image showing a collapse
8" sewer Middlesex Avenue*

Somerville Sewer Line Repair

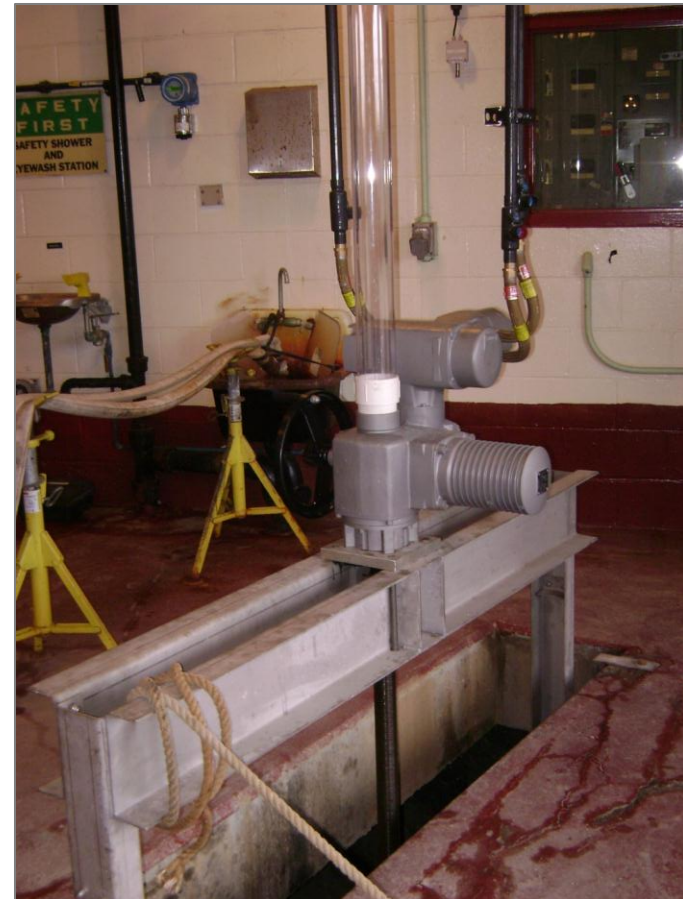
*Top of gate in screening room
(one of two new influent gates)*

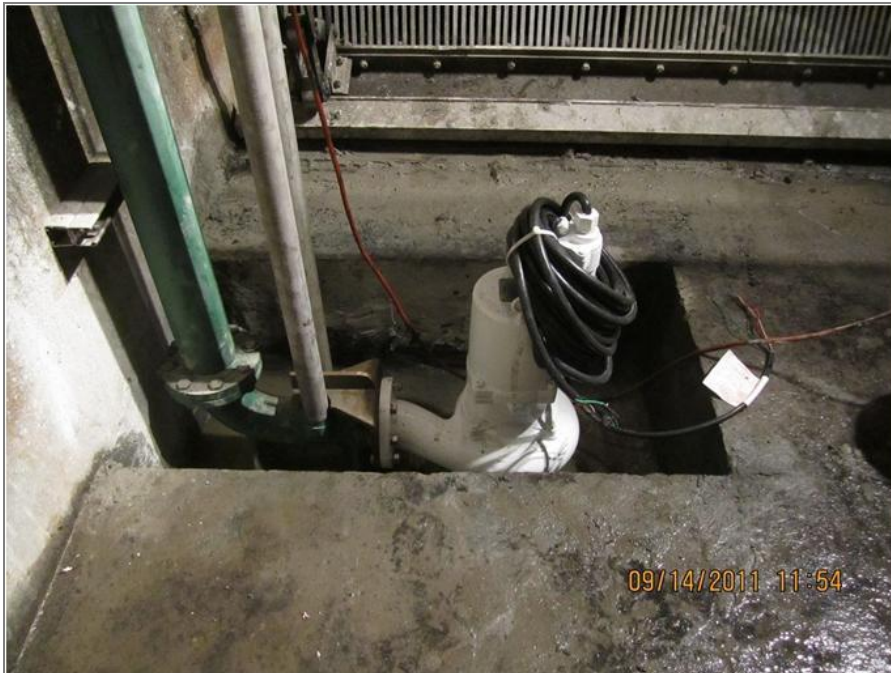
One of two new dewatering pumps in influent channel downstream of gate.
